RECESSED LOCOS SCHEME
(BEFORE FIELD OXIDATION)

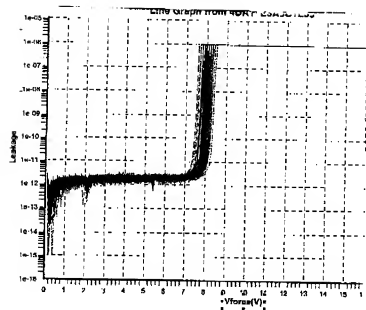
fig 5D. (electrical monitoring)

從fig 5D可看出

well junction measurement results
show that no silicon defect was induced by
isolation process.

⇒ 電信測量圖 (做完 isolation process 後測得)。
